## H8 Front Panel Fixes:

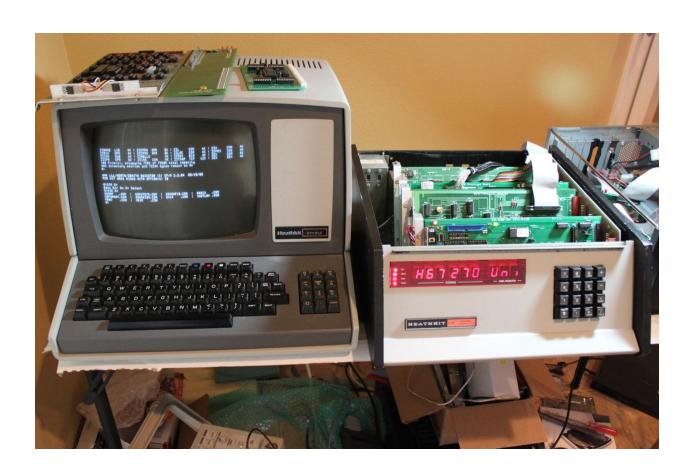
- 1. Insert PAM-37 ROM in U4
- 2. Insert XCON-8 ROM into U3
- 3. Insert jumper between U4 pin 1 and 2 (Primary ROM PAM-37)
- 4. Insert jumper between U3 pin 2 and 3 (Secondary ROM XCON-8))
